Contract #: 04-0120F4Cty: SF/ALA Rte: 80 PM: 13.2/13.9File #: 69.28**WELDING INSPECTION REPORT****Resident Engineer:** Pursell, Gary**Address:** 333 Burma Road**City:** Oakland, CA 94607**Report No:** WIR-004509**Date Inspected:** 01-Nov-2008**Project Name:** SAS Superstructure**OSM Arrival Time:** 1400**Prime Contractor:** American Bridge/Fluor Enterprises, a JV**OSM Departure Time:** 2300**Contractor:** Zhenhua Port Machinery Company, Ltd (ZPMC), Changxing Island **Location:** Shanghai China**CWI Name:** Zhu Zhong Hai**CWI Present:** Yes No**Inspected CWI report:** Yes No N/A**Rod Oven in Use:** Yes No N/A**Electrode to specification:** Yes No N/A**Weld Procedures Followed:** Yes No N/A**Qualified Welders:** Yes No N/A**Verified Joint Fit-up:** Yes No N/A**Approved Drawings:** Yes No N/A**Approved WPS:** Yes No N/A**Delayed / Cancelled:** Yes No N/A**Bridge No:** 34-0006**Component:** Tower**Summary of Items Observed:**

89M mock up

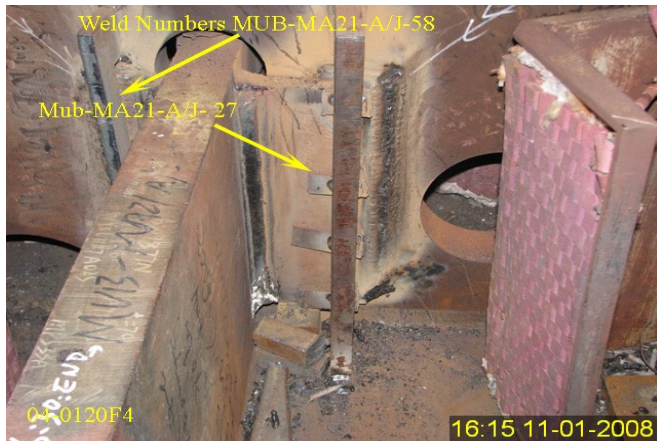
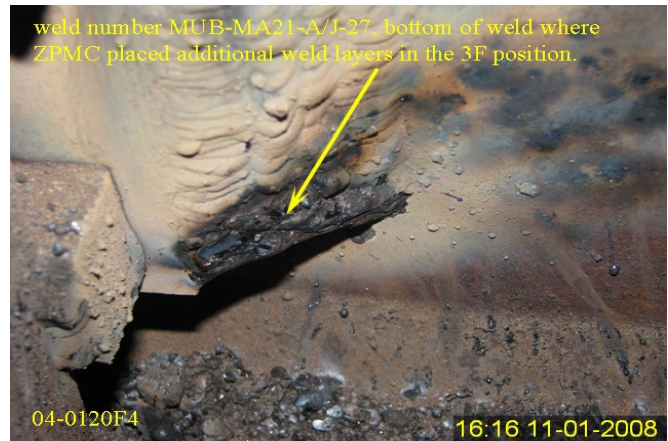
Caltrans QA Inspector observed that ZPMC was performing the welding of fit-lug to diaphragm plate on 2 welds; these welds were identified as MUB-MA21-A/J-58 and MUB-MA21-A/J-27. Upon the arrival of this QA inspector it was observed that ZPMC was using 2 different welding procedures and 2 different fit lug sizes for these locations. Weld number MUB-MA21-A/J-58, used a fit lug size of 75 mm x 370mm x 30mm with welding procedure ABF-WPS-D15-F1202A using welding electrode E7018 C3L H4R, 3.2mm electrode was being applied by welder # 067993 with the SMAW welding process. The welding parameters for this location was pre-heat of 189°C, 130 amps, 24 volts and a travel speed of 95mm/min. Weld number MUB-MA21-A/J-27 used a fit lug size of 150mm x 370mm x 30mm with welding procedure WPS-B-T-4113-2 with welding electrode E7018-1, 4.0mm diameter applied by welder # 068924. ZPMC completed the MT of the root passes by technician Cai Xin Xin with acceptable results as stated by ZPMC. ABF personnel were present for the MT and also accepted these results for the hold point as outlined within the procedure. According to the ABF letter dated October 14, 2008 the weld trials were to be done by using "the same equipment, equipment set up, welders and QC/QA staff" it has been observed and documented that ZPMC has not used the same welders for these trials. The welders used are as follows; for date 10-28-08, FCAW welders 067079 and 066734, for date 10-30-08, SMAW welders 054467 and 048659 and for today's date 11-1-08, SMAW welders 067993 and 068924 (for 10-31-08 this QA inspector was not present due to scheduled day off, unknown of which welders used). The starting time and temperatures for the controlled cool down started at 1200 hrs with a starting temperature of 198°C the ambient temperature was approximately 27°C. Below are the details of the controlled cool down.

1200 hrs – 198°C (Start of cool down)
1230 hrs – 186°C
1300 hrs – 172°C (26°C drop in 1 hour)
1330 hrs – 156°C
1400 hrs – 140°C (32°C drop in 1 hour)
1430 hrs – 122°C
1500 hrs – 108°C (32°C drop in 1 hour)
1530 hrs – 90°C
1600 hrs – 72°C (36°C drop in 1 hour)
1630 hrs – 57°C
1700 hrs – 49°C (23°C drop in 1 hour)
1730 hrs – 39°C
1800 hrs – 35°C (14°C drop in 1 hour)

The controlled cool down appears to be within the requirements of the submitted procedure by ABF.
